Thermography uncovered

Thermography is being used more and more across the UK, but how useful is it? We find out more about this new diagnostic tool and the role it has to play in the horse world

Testing the boundaries

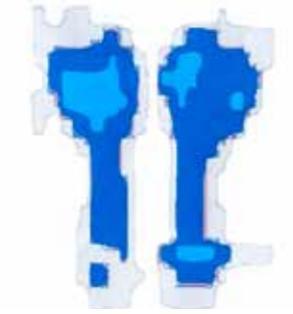
Thermography results showed there was an increase in temperatures on the left side of the saddle panel.

The Pliance results (left) showed higher pressure at both sides of the wither and at the back of the panel on the right side, which correlates with Skippy's saddle moving to the left. This meant that, visually speaking, the thermographic imaging (below left) was misleading as the heat did not reflect the pressure that showed up in the Pliance readings.

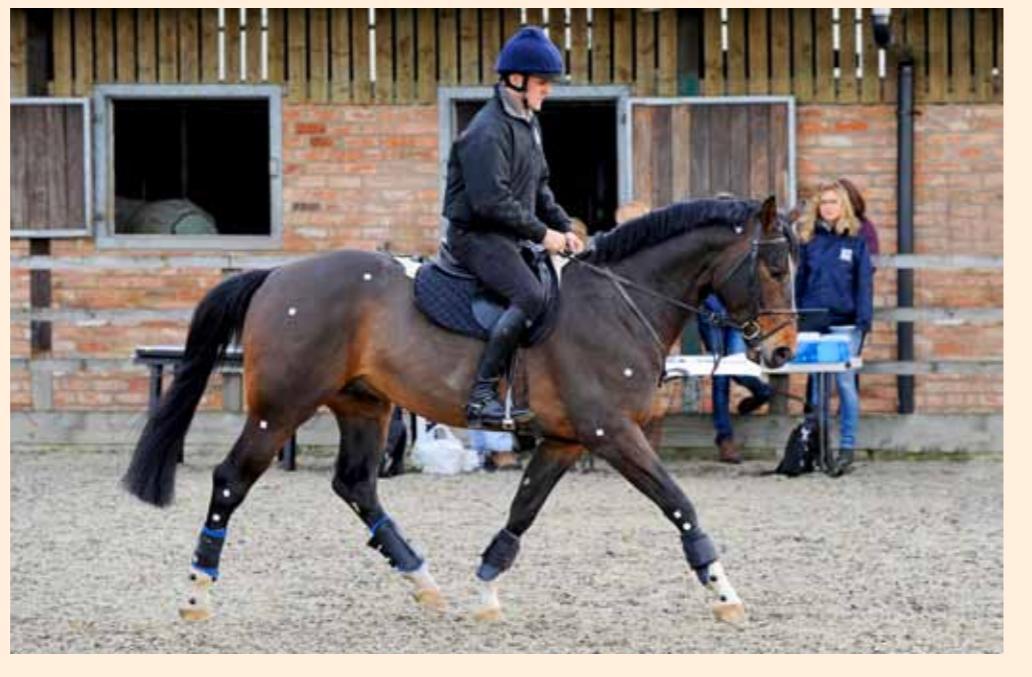
The thermographic imaging detected a slight imbalance to the left panel of his saddle.

The thermographic images appear to say that the saddle has four point panel contact, which it doesn't. If you used just these results to assess whether his saddle fitted, this would give an inaccurate result. Thermography did detect muscular tightness in the neck and cold areas developed in the back post lungeing.

When ridden with the Pliance system, increased pressure showed on the right panel towards the front of his saddle. This result tallies with the comments of the saddle fitter - interference caused by his large right shoulder.

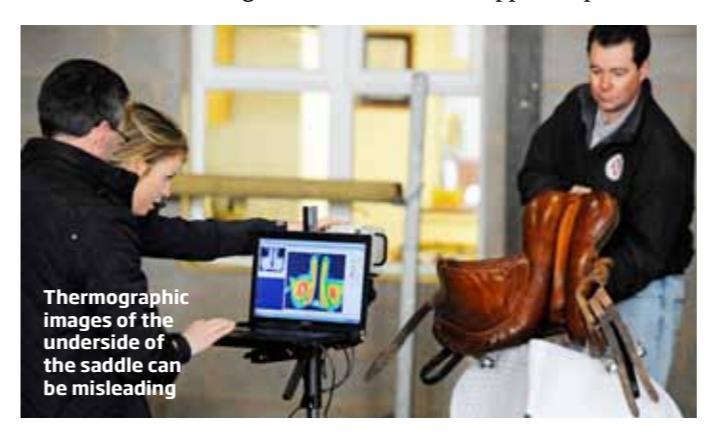
The thermographic images of the saddle showed a slight imbalance to the left panel. The image of the saddle panels are visually misleading - if you based your findings on these results alone, they'd suggest that the saddle has a good contact area despite being much too narrow for him.

The Pliance results showed very high pressures either side of his withers indicating the saddle is far too narrow for him.

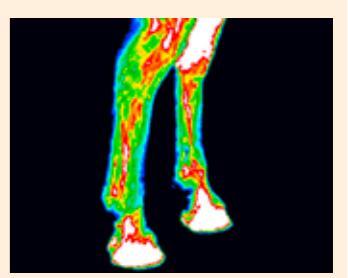
On the thermography there was no evidence to suggest the saddle was tight each side of Buster's withers.

Buster was an interesting case - although the results from the thermography were inaccurate in the assessment of the saddle fit, they did detect a number of other dysfunctions specific to his right hindleg which were worthy of further investigation. This also correlated with other professional reports from the vet and physio on the day.
